TD-04-039  
10/04

## EDDY CURRENT SCANNING REPORT

### FNAL-3RDHARMONIC CAVITY #2

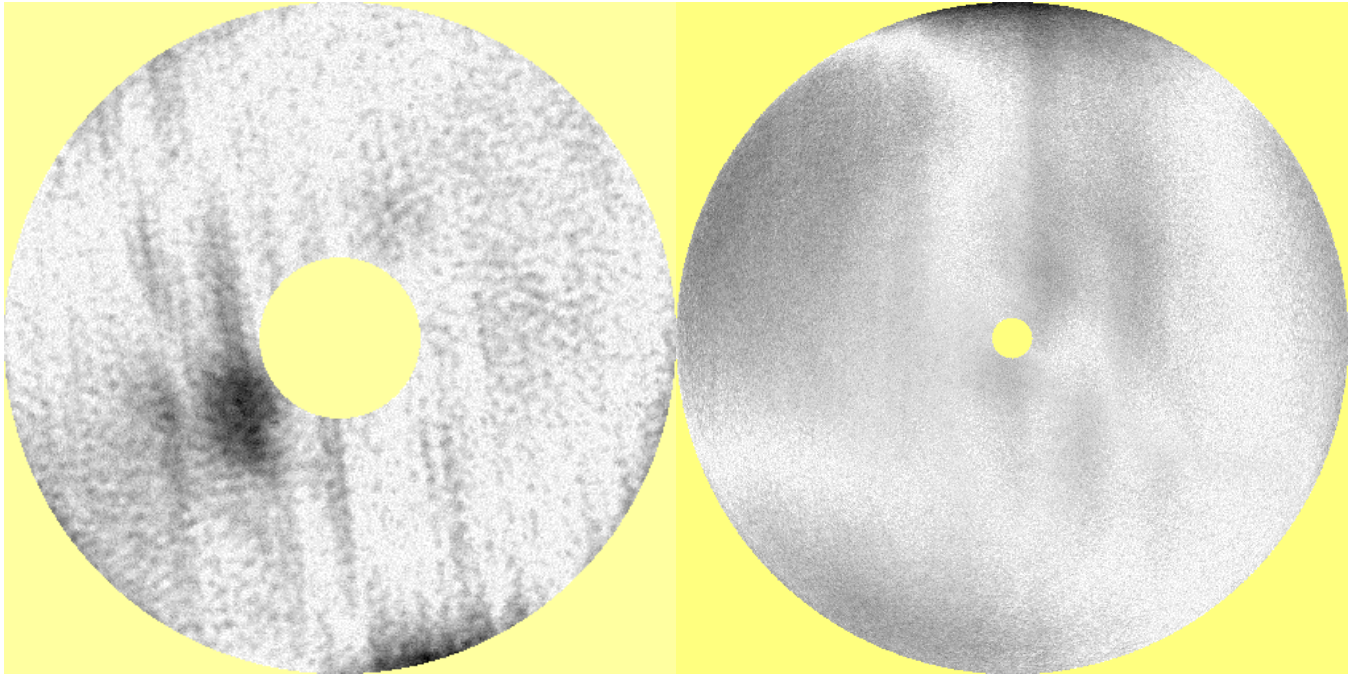
Disc 1 – side 1: DESY (left), SNS/FNAL (right);

| # | disc | comment |
|---|---|--|
| 1 | 1 | S1: ok<br>S2: scratch 0 MR ( <b>defect 120 HR in DESY scan</b> )<br>Large thickness variation |

| # | SIDE 1 | SIDE 2 | ADD. COMMENT | RECOM |
|---|--|---|--|---|
| 1 | OK | defect (ECS), scratch (VI) | S2 scratched from scanning | S1 |

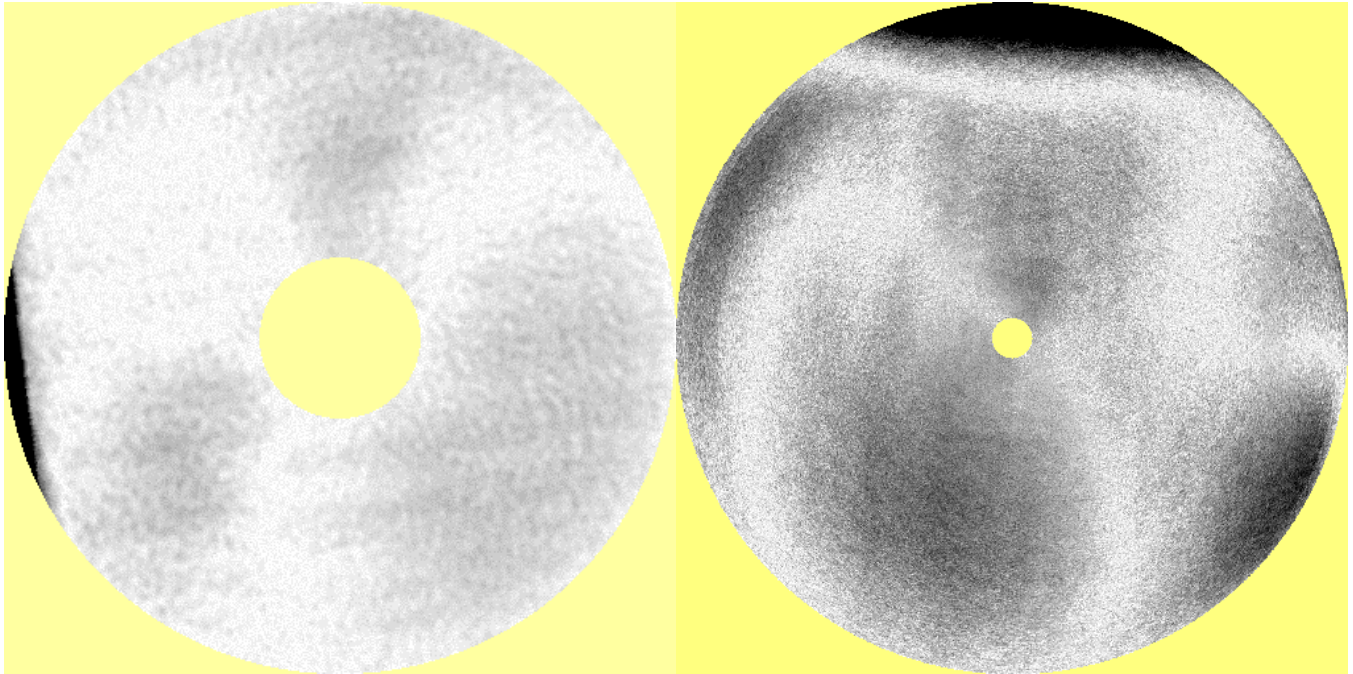
Disc 3 – side 1: DESY (left), SNS/FNAL (right); disc was rotated by ~90 degrees in FNAL scanner in order to fit into sample-holder (major difficulties to remove disc from sample-holder ensued);

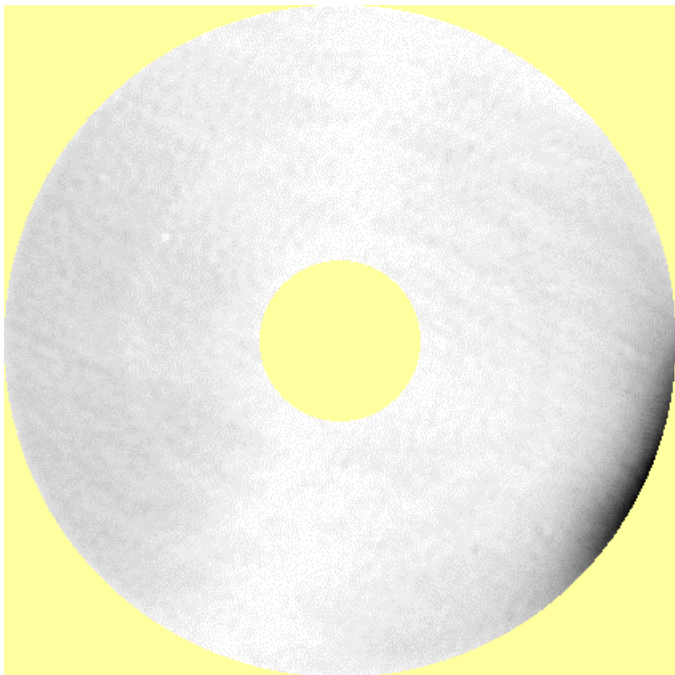
Disc 3 – side 2: DESY (left), disc could not be fit into SNS/FNAL scanner;

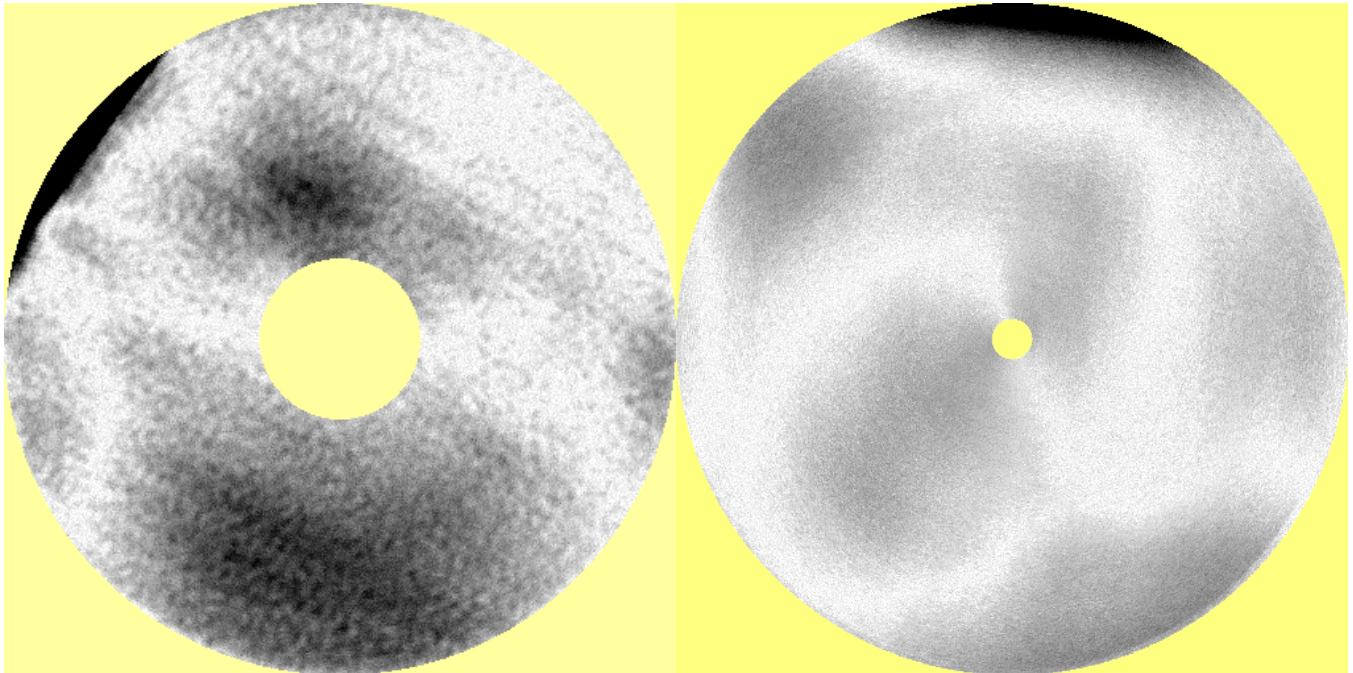
Disc 5 – side 1: DESY (left), SNS/FNAL (right), discs were not oriented the same because direction marks were missing;

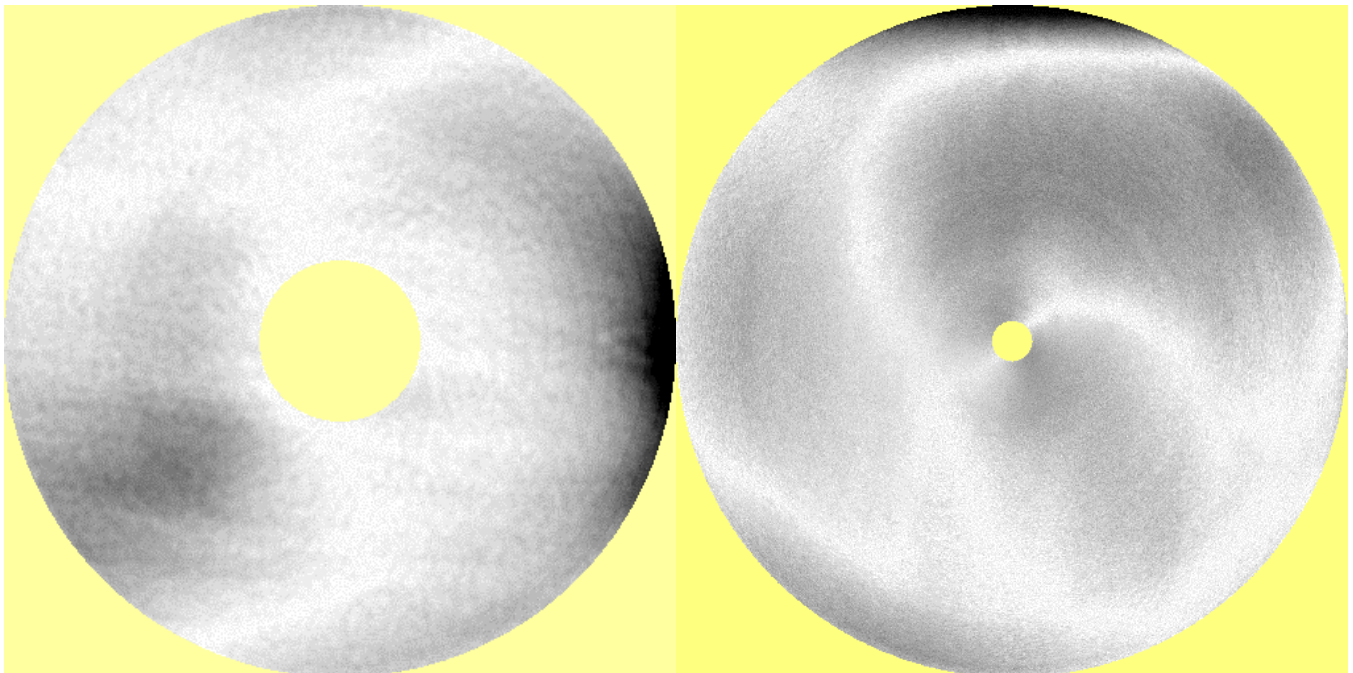
Disc 5 – side 2: DESY (left), SNS/FNAL (right), discs were not oriented the same because direction marks were missing;

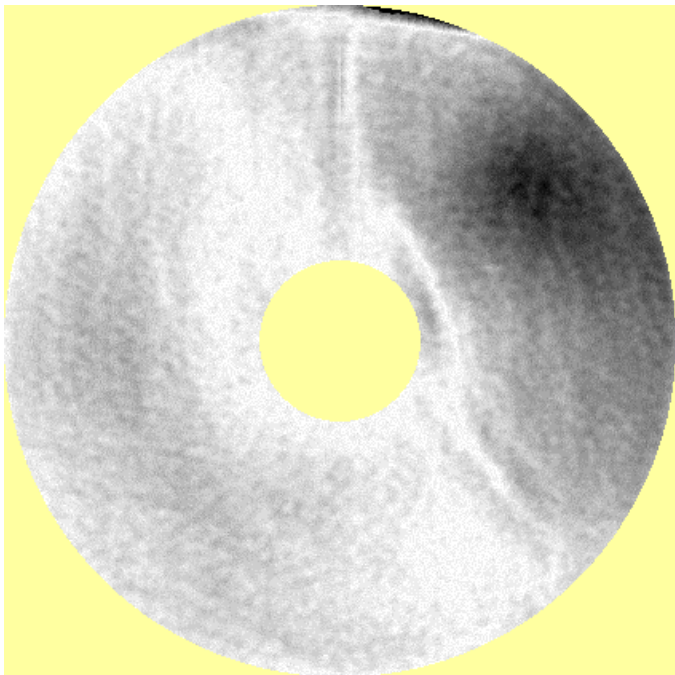
Disc 7 – side 2: DESY (left), disc did not fit SNS/FNAL scanner;

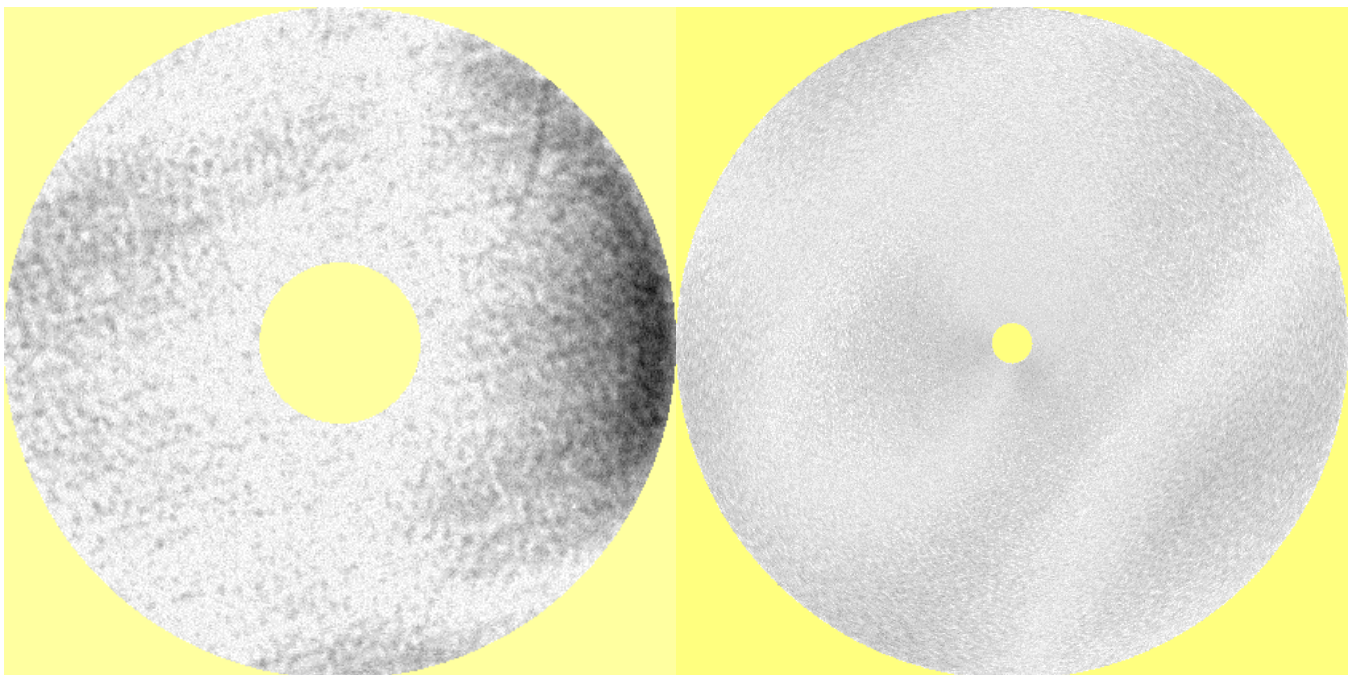
Disc 8 – side 2: DESY (left), SNS/FNAL (right);

| # | SIDE 1 | SIDE 2 | ADD. COMMENT | RECOM |
|---|--|---|--|---|
| 8 | defects (ECS), pits & scratches from scan (VI) | scratches (VI) | S1 scratches removed with ~50 µm etch | S1 * |

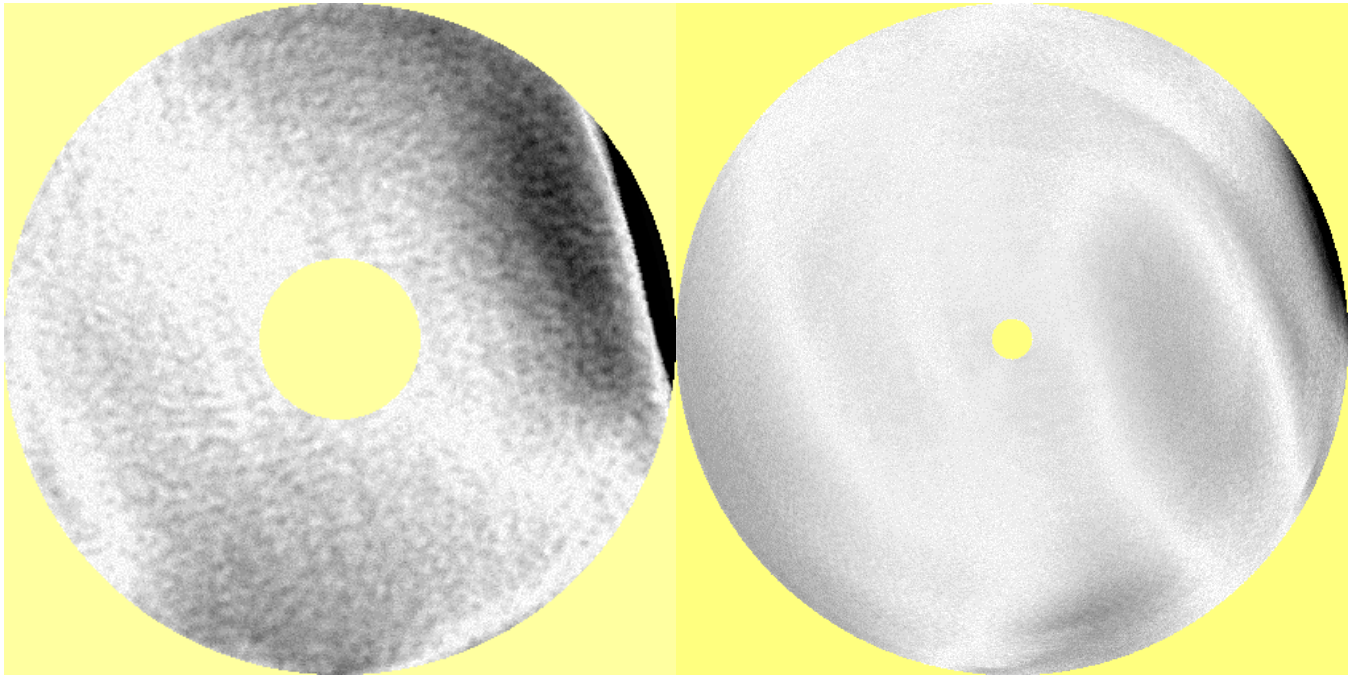
Disc 12 – side 1: DESY (left), SNS/FNAL (right);

| # | SIDE 1 | SIDE 2 | ADD. COMMENT | RECOM |
|---|--|---|--|---|
| 12 | scratches (VI) | defect (ECS), scratches (VI) | S2 scratched from scanning, S1 scratches removed ~50 µm etch | S1 * |

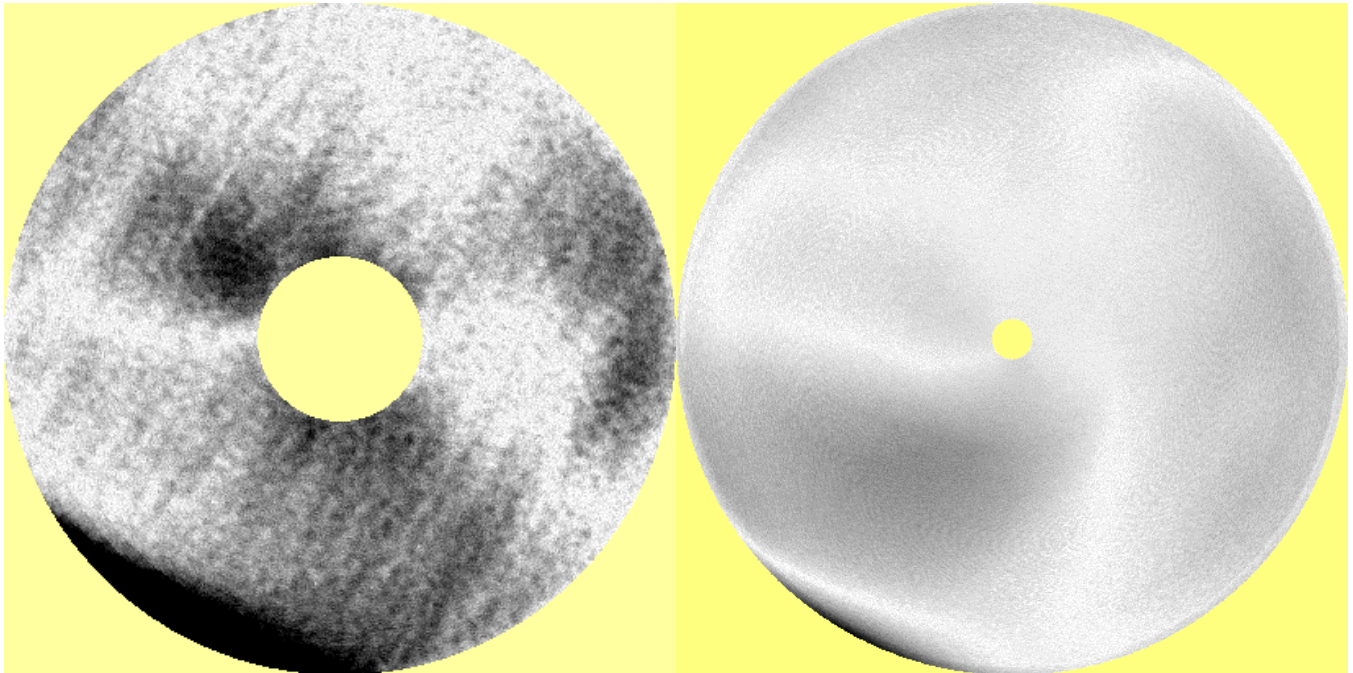
Disc 14 – side 1: DESY (left), SNS/FNAL (right);

| # | disc | comment |
|---|---|--|
| 14 | 14 | S1: <b>dent 200 HR</b> , dent 25 OR<br>S2: <b>pits 0-90 &amp; 260-360 HR, scratches HR-OR (13 defects 285 HR in DESY scan)</b> |

| # | SIDE 1 | SIDE 2 | ADD. COMMENT | RECOM |
|---|--|---|--|---|
| 14 | dent (VI) | defects (ECS), pits (VI) | not usable after 175 µm etch | NO |

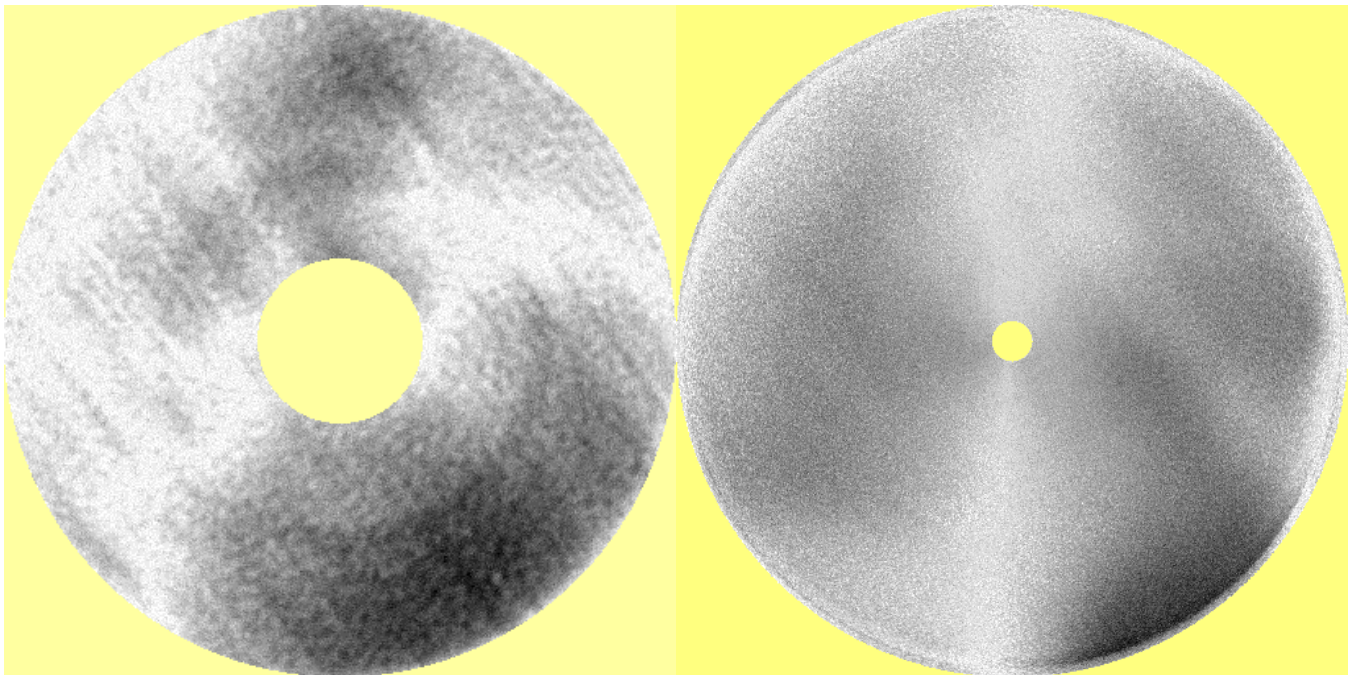
Disc 17 – side 2: DESY (left), SNS/FNAL (right);

| # | SIDE 1 | SIDE 2 | ADD. COMMENT | RECOM |
|---|--|---|--|---|
| 17 | defects (ECS), pits (VI) | scratches (VI) | S1 scratched from scanning, S2 scratches removed w ~50 µm etch | S2 * |

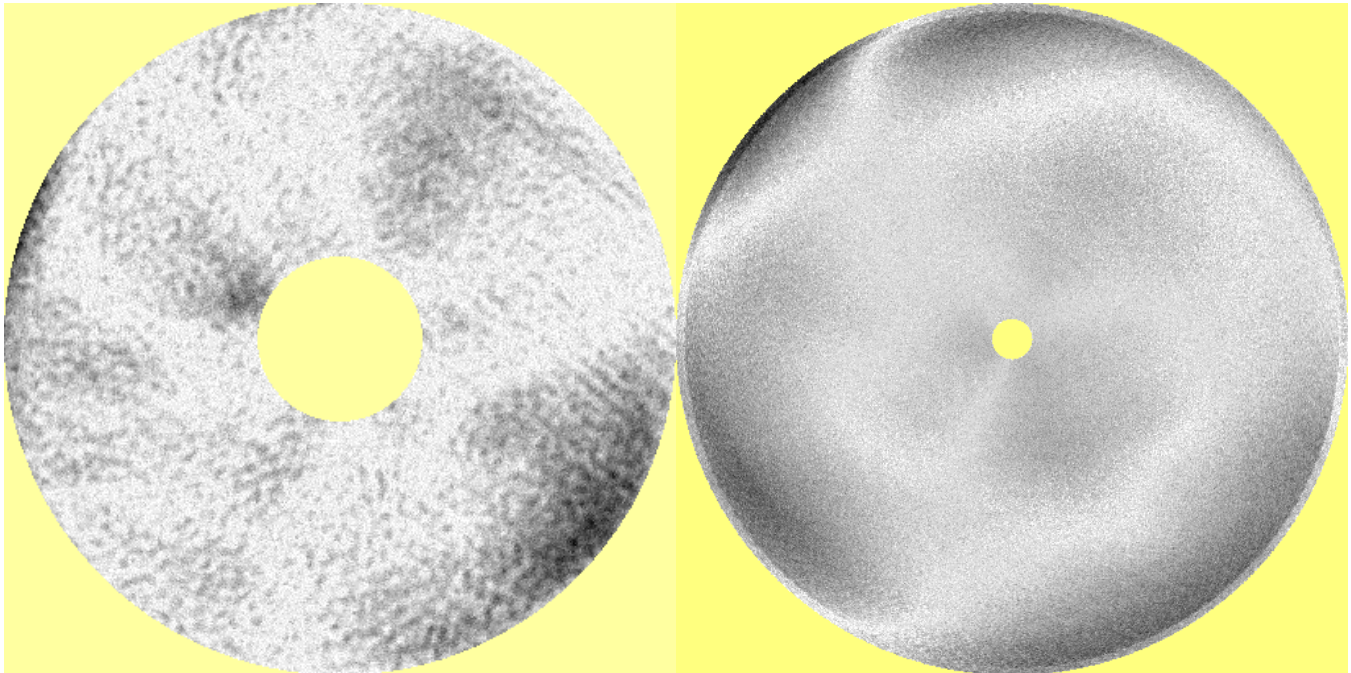
Disc 19 – side 1: DESY (left), SNS/FNAL (right);

| # | disc | comment |
|---|---|--|
| 17 | 19 | S1: pit 75 OR, scratch 300 OR<br>S2: <b>scratches, dent 30 HR (defect 12 HR in DESY scan)</b> |

| # | SIDE 1 | SIDE 2 | ADD. COMMENT | RECOM |
|---|--|---|--|---|
| 19 | long (shallow?) scratch (VI) | defect(ECS),pits&scratches (VI) | disc etched 50 µm | NO(S1) |

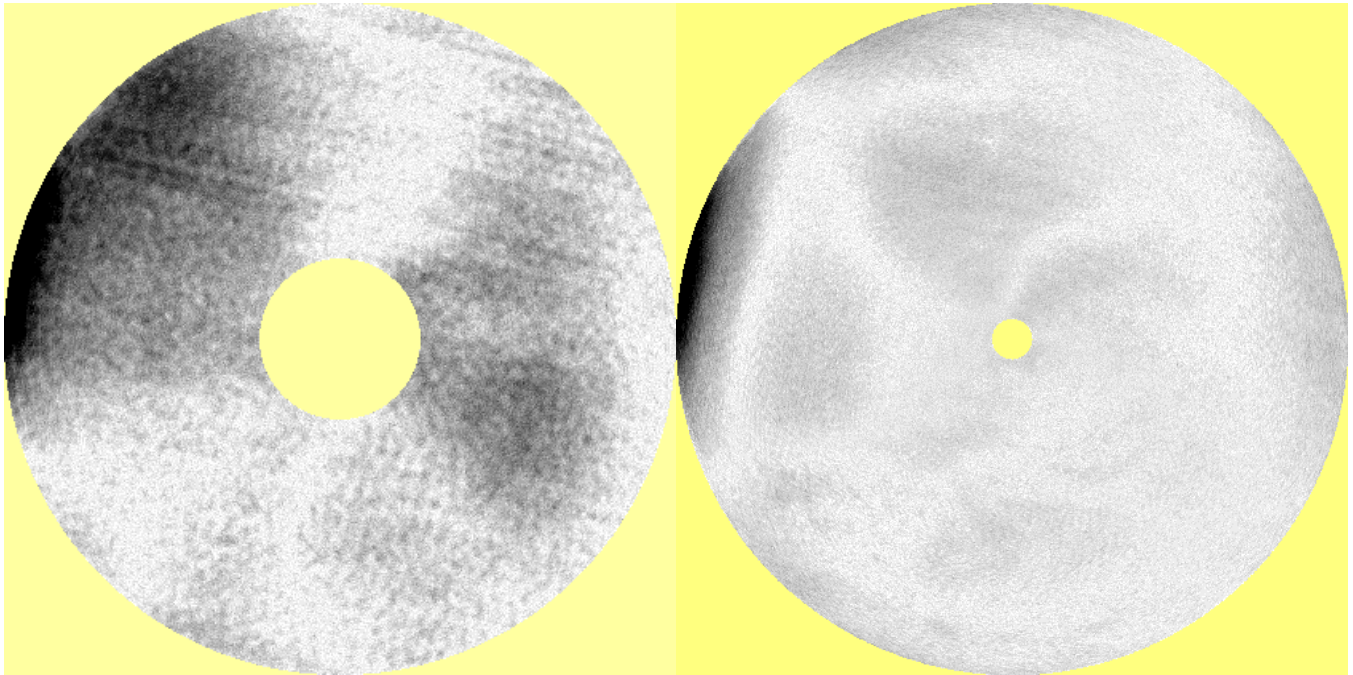
Disc 27– side 1: DESY (left), SNS/FNAL (right);

| # | SIDE 1 | SIDE 2 | ADD. COMMENT | RECOM |
|---|--|---|--|---|
| 27 | small scratch, weak scan marks | defects(ECS), pits&scratches(VI) | - | S1 |

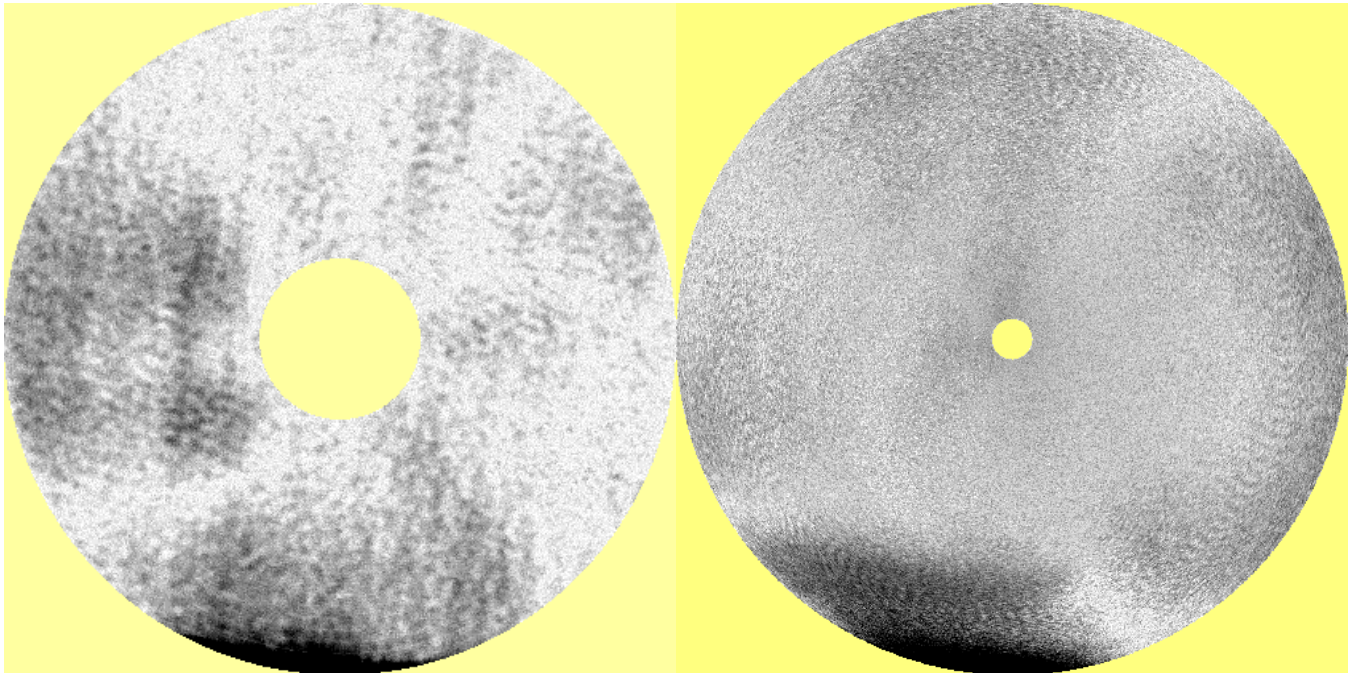
Disc 32 – side 1: DESY (left), SNS/FNAL (right);

| # | disc | comment |
|---|---|---|
| 22 | 32 | S1: <b>ding 40 OR-HR</b><br>S2: <b>scratches, dings and specks 170-200 HR (defect 180 HR in DESY scan)</b> |

| # | SIDE 1 | SIDE 2 | ADD. COMMENT | RECOM |
|---|--|---|--|---|
| 32 | dent (VI) | defects(ECS), pits&scratches(VI) | S1 scratches removed with ~50 µm etch | S1 * |

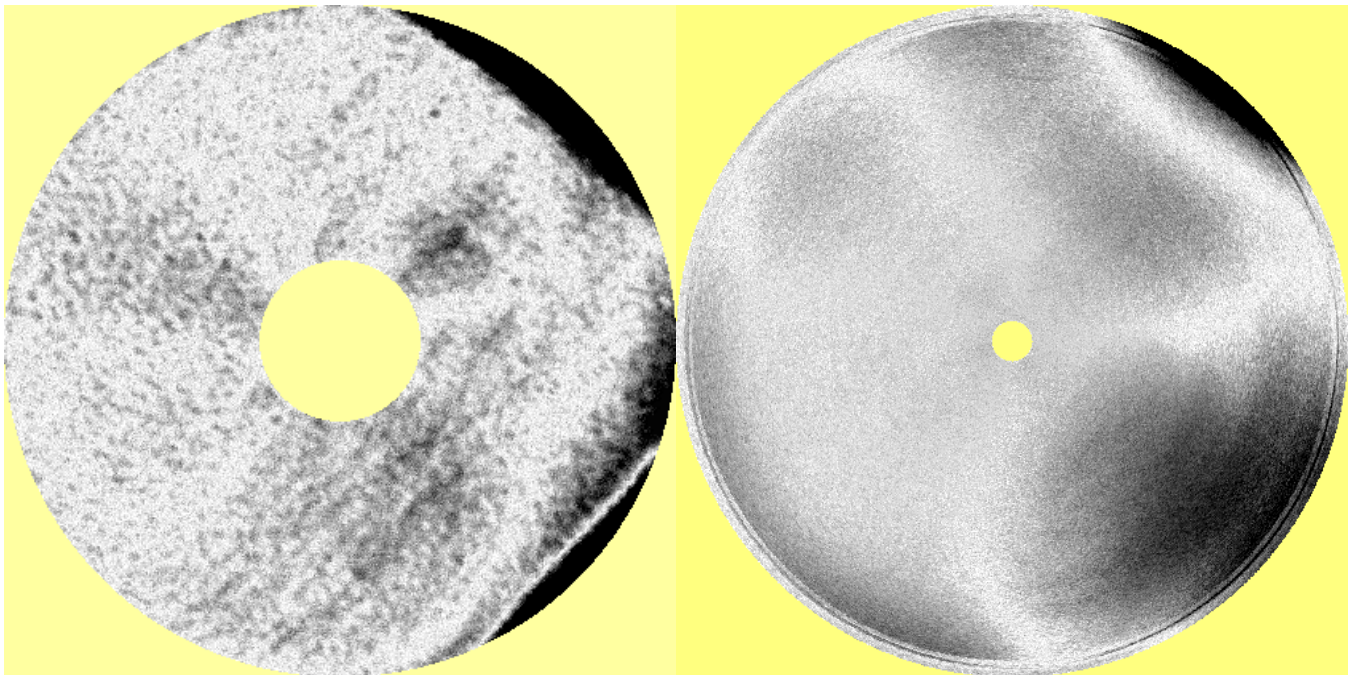
Disc 47 – side 1: DESY (left), SNS/FNAL (right), defects found in DESY scan;

| # | SIDE 1 | SIDE 2 | ADD. COMMENT | RECOM |
|---|--|---|--|---|
| 47 | defect (ECS), pits&scratches (VI) | OK | - | S2 |

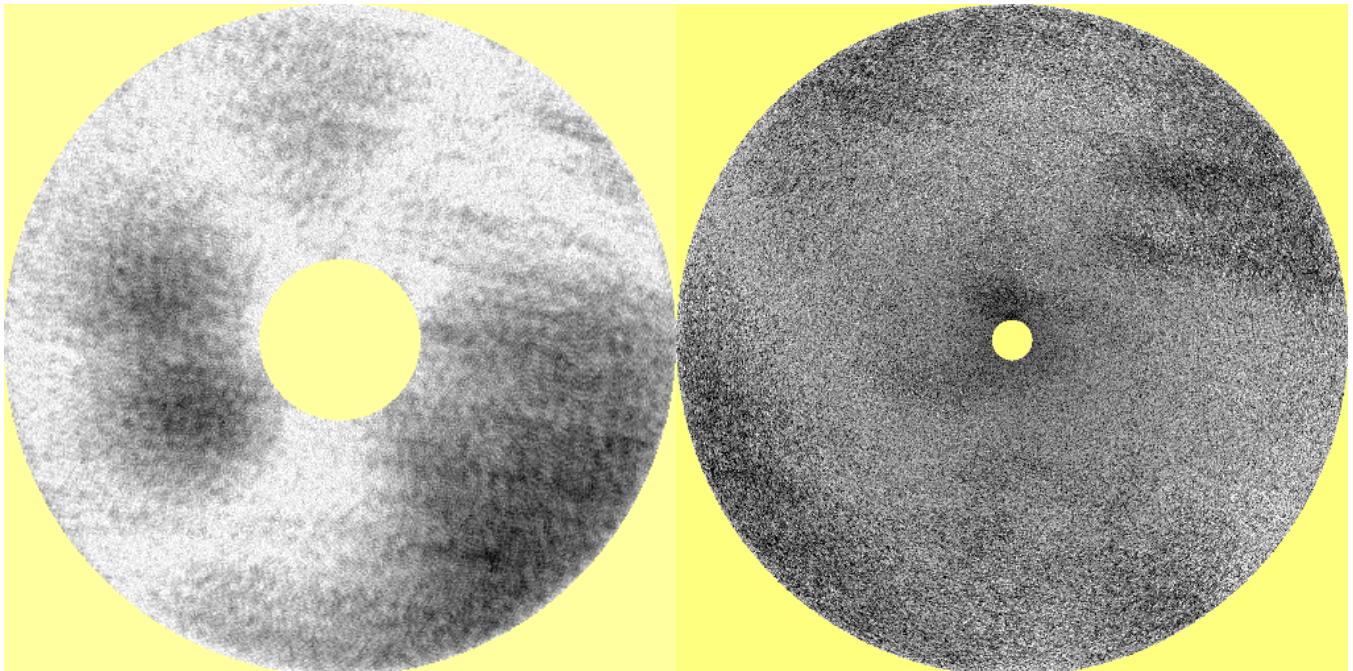
Disc 51 – side 1: DESY (left), SNS/FNAL (right), defects found in DESY scan;

| # | SIDE 1 | SIDE 2 | ADD. COMMENT | RECOM |
|---|--|---|--|---|
| 51 | defects (ECS) pits&scratches (VI) | scratch MR&weak scanmarks(VI) | - | NO(S2) |

According to the here presented classification 14 discs can be used immediately in a cavity. The other four discs needed for the 3<sup>rd</sup> harmonic cavity could be obtained from the set of eleven discs with the NO(S1,2) label. We proceeded with BCP etching eight discs from this category by 50  $\mu\text{m}$ . These discs are labeled with a \* symbol in Table 3. All eight discs were indeed repaired in this process and can now also be used in the fabrication of the 2<sup>nd</sup> prototype of the 3<sup>rd</sup> harmonic cavity. A special etching fixture was prepared to pre-etch the discs. It is shown in Figure 8. Three additional discs (19, 42, 51) listed in Table 3 can also be repaired by pre-etching, should the need arise.
